Repair of Yanmar Tach-Hour meter, discussion. November 30, 2012

Problem: Hour meter display is erratic, faint or flashing numerals, or no display. Hour counter is still operating but display is unreliable, unreadable or simply out.

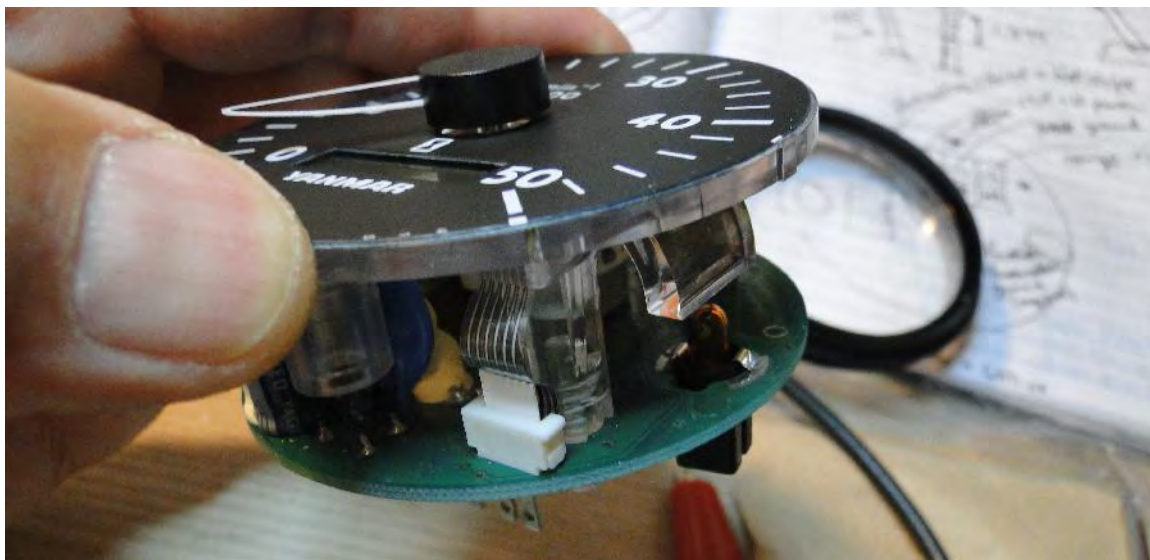
1. Tach-Hour Meter assembly lifted out of housing showing display ribbon cable and connector.

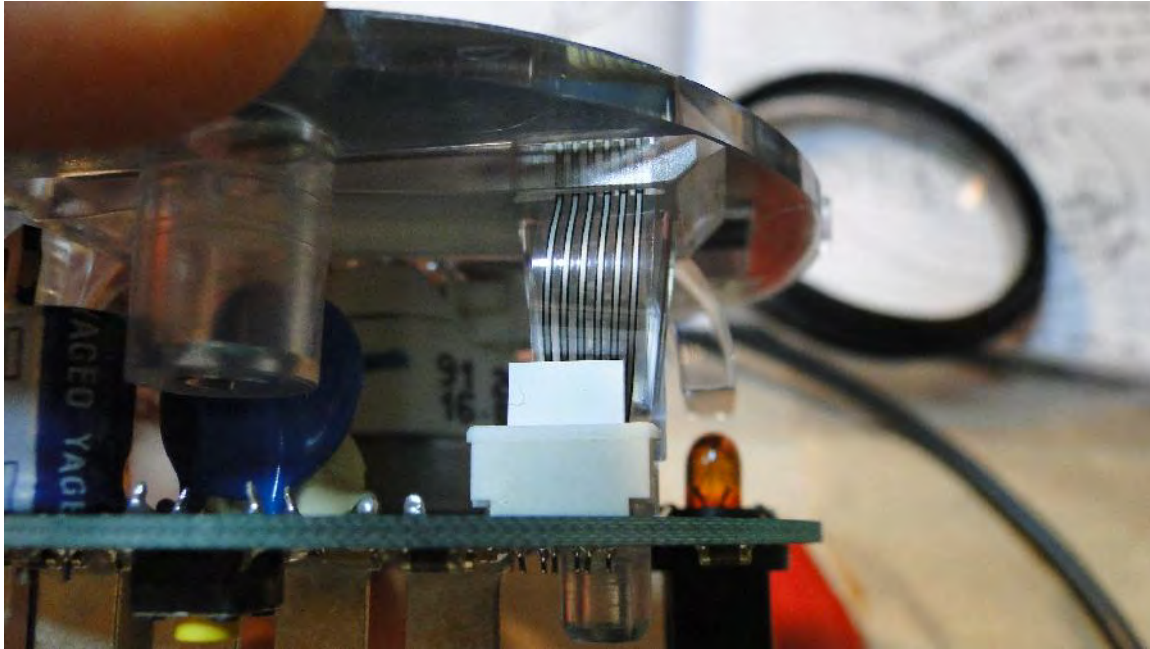
2. Tach-Hour meter assembly showing display ribbon cable and connector. Note connector collar down in the capture position.

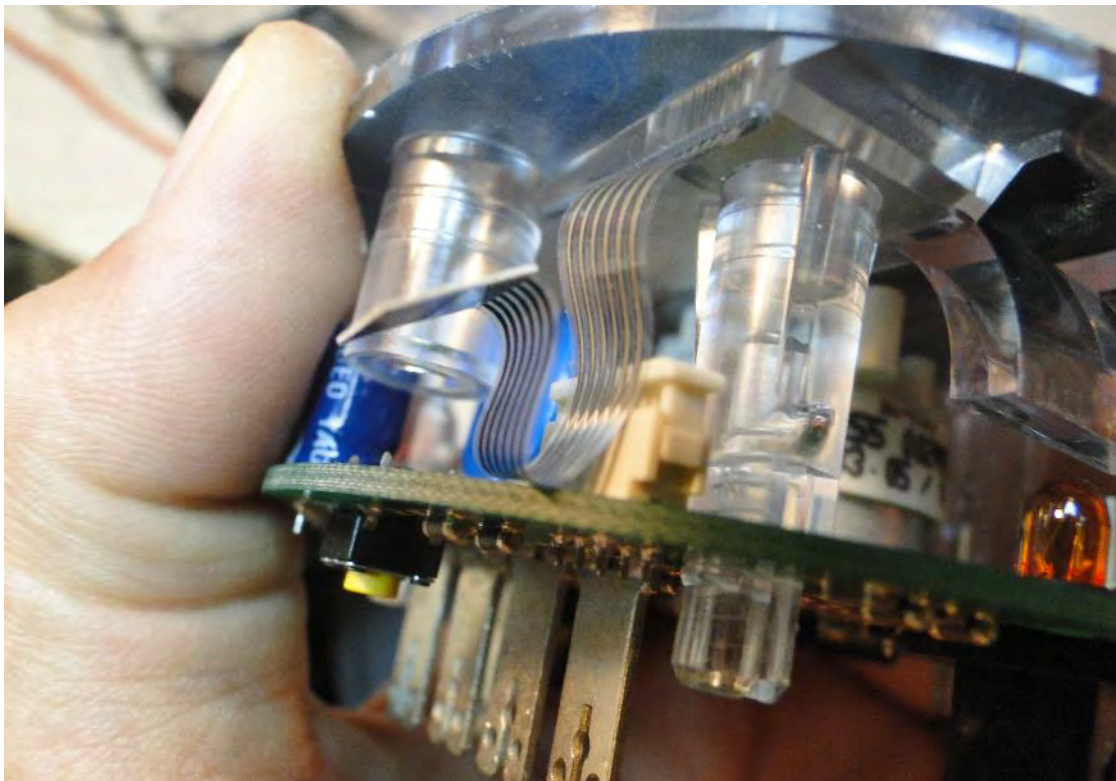
3. Circuit board end of display ribbon cable out of socket. Note socket collar lifted up in the release position. This end of the display cable and its circuit board connector were originally thought to be the source of the problem. After cleaning these connections and application of silicone grease to create a gas tight fitting, the display continued to fail.

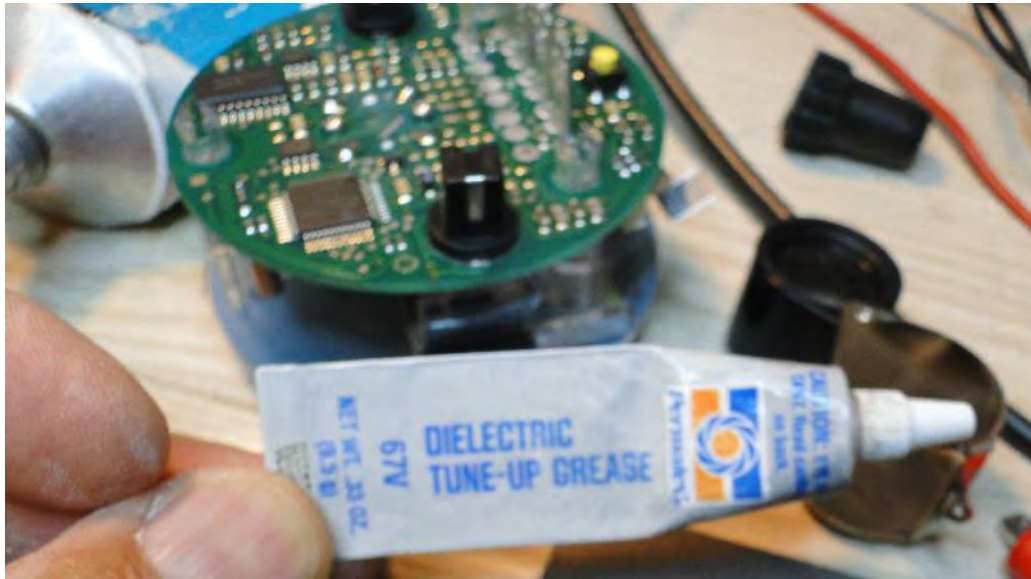
4. Silicone grease used on connector end of ribbon cable to create gas tight connection between ribbon connector cable and connector.

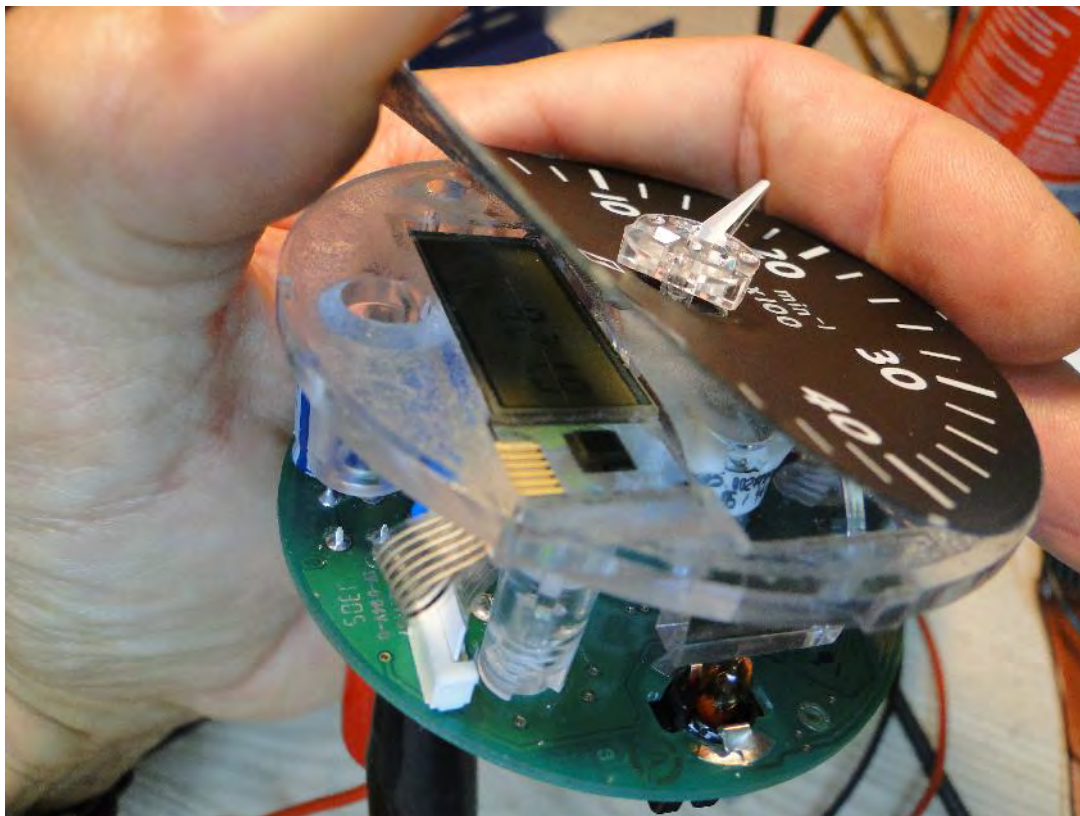
5. Thumb holding face plate up to expose ribbon connection area including LCD and IC at the right of the LDC display.

Challenge: Access to the trouble area requires careful lifting of the face display which is glued down. I used a razor blade and exacto knife to separate the face plate from the mounting face.

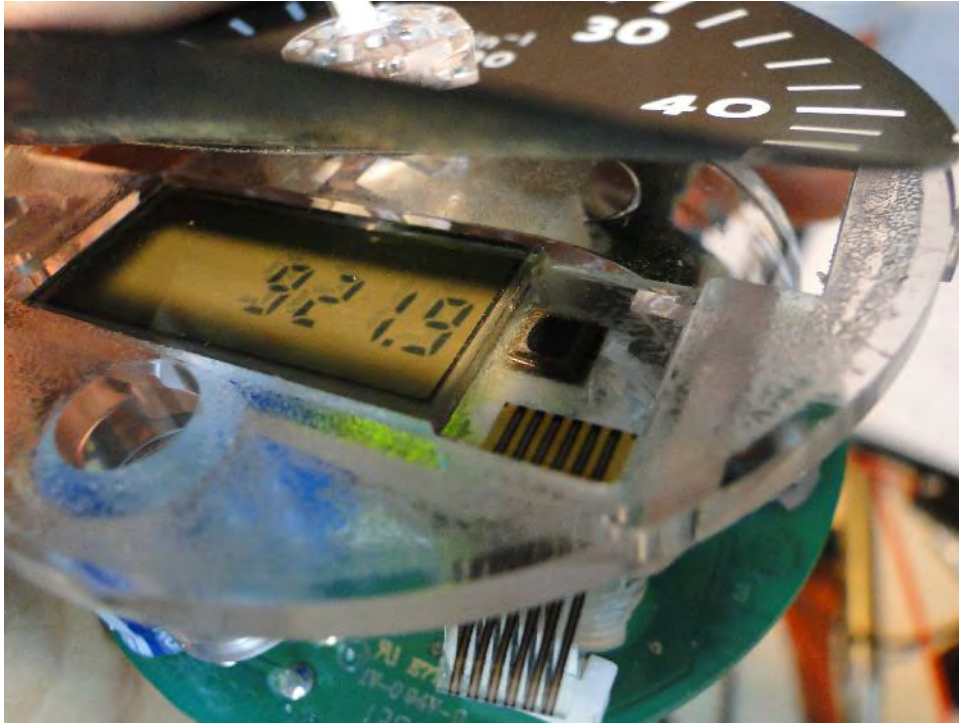
6. Thumb holding face plate up to expose ribbon connection area including LCD and IC at the right of the LDC display. A close-up of this area in the next photo.

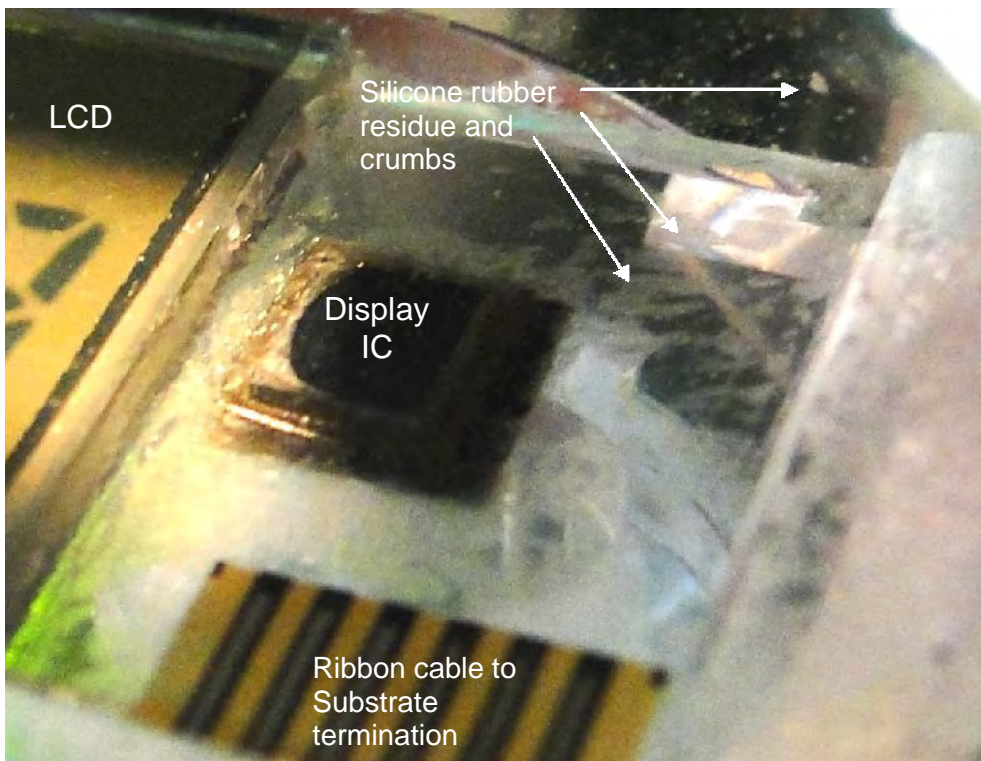
Root cause: Defective silicone rubber applied over the IC, ribbon connection and LCD substrate became conductive or trapped contaminants and/or humidity and disrupted circuit interconnections on the LCD display substrate which includes transparent Indium Tin Oxide conductors and a surface mounted integrated circuit.

7. Close up of LCD substrate area where ribbon cable connects and IC is connected. This entire area had the failed/defective silicone rubber compound applied. Residue is still present on the substrate surface. Not done yet.

Having lifted this face plate, a wooden tooth pick, chisel shaped, is used to dislodge and remove the failed/defective silicone rubber which crumbled away from the substrate, ribbon cable connection area and integrated circuit. A wooden tooth pick is recommended because it will not scratch the LCD substrate, ribbon cable or IC. The LCD substrate has transparent conductive oxide electrodes made of the transparent conductor Indium Tin Oxide (ITO).

The silicone compound covering this area flaked off and crumbled readily. It must be scraped away from all surfaces to which it was applied. A can of air is helpful to blow the crumbs away. A small stiff brush can also be helpful. Once the majority of the material is removed, a careful going over of the surfaces with a fresh, sharpened chisel flat, wooden toothpick will remove the last bit of residue. This last step is very very important because the defective silicone rubber on the surface of the LCD substrate must be fully removed to eliminate spurious conductive paths.

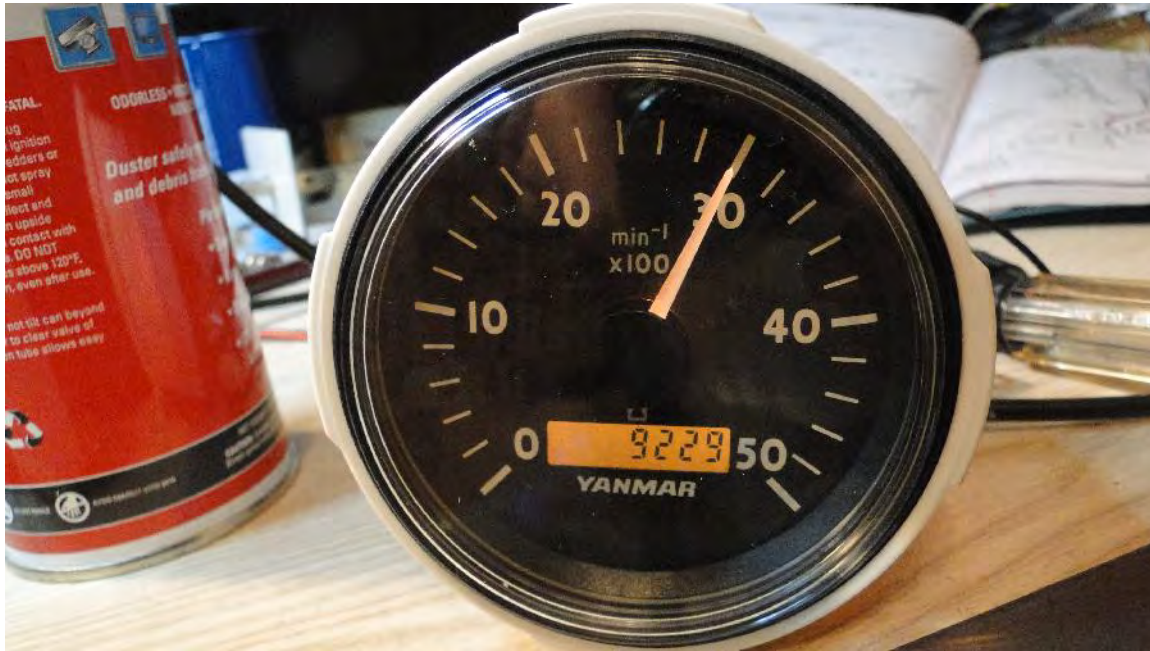
8. Reassembled Tach-Hour unit with persistent, bright, well defined numerals in hour display. Tach shows 3000 RPM with 510 Hertz square wave applied to tach input.
